Emission Microscope and Passive Voltage Contrast: Solving A Problem Quickly

by Mehrdad Mahanpour, Advanced Micro Devices

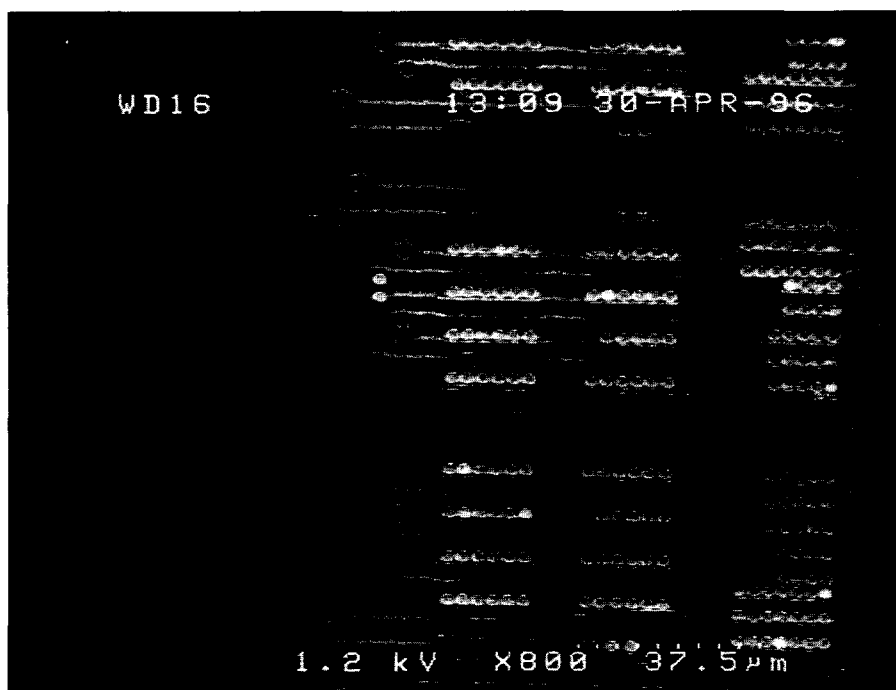
Figure 5a. Passive voltage contrast is showing the leaky poly.

With follow-up inspection, the analyst should concentrate on looking at the poly contacts in the area where emission was observed. Since poly contacts are dark, if one contact is bright then this leads us to the defective poly or gate oxide (Figure 5). To confirm this poly contact's brightness, the analyst should zoom-in to the contact (7000x) and then zoom-out (800x). If the poly is not defective it builds-up charge at the contact and remains dark and if defective (shorted to substrate), the poly contact becomes bright.

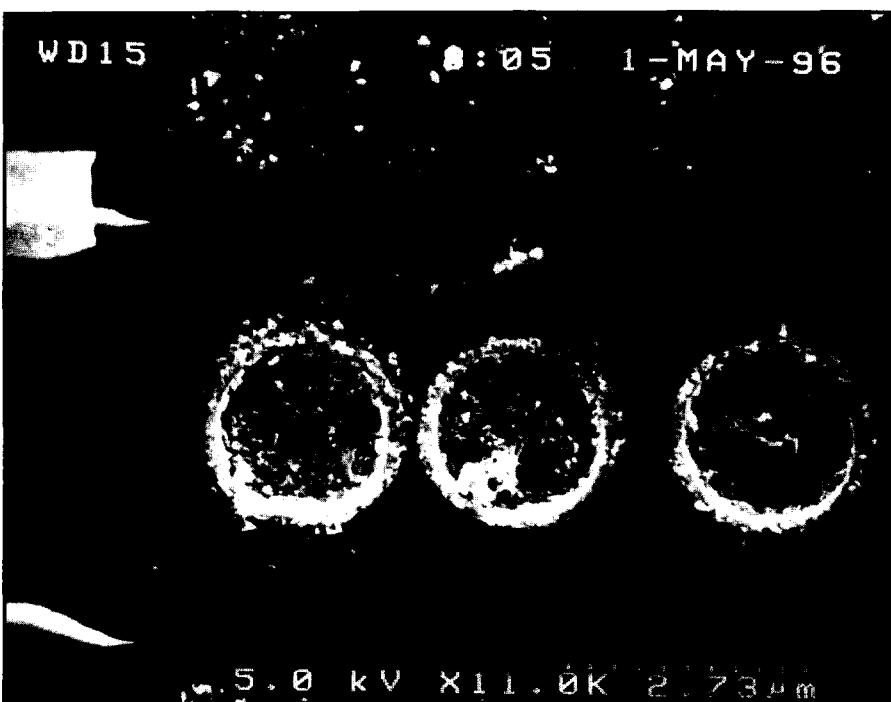
Figure 7b: Same as figure 7a at higher magnification.
